Home Inspection Report

1234 School House Road
Yourtown, US 12345

Prepared for: Bob Smith

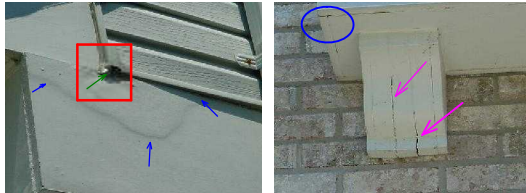
1. The wood window boxes have water damage and will require repair/replacement. The wood has started to separate at the supports and at the corners of the window boxes.

2. The trim board at the southwest corner of the porch has water damage due to water penetration and will require repair/replacement of the wood. The trim board extends out creating a ledge allowing water to collect on the top edge of the board and cause the wood to rot.

Recommend estimate/repairs by a qualified contractor.
